PCB-Containing Fluorescent Light Ballasts

(adapted from EPA fact sheets)

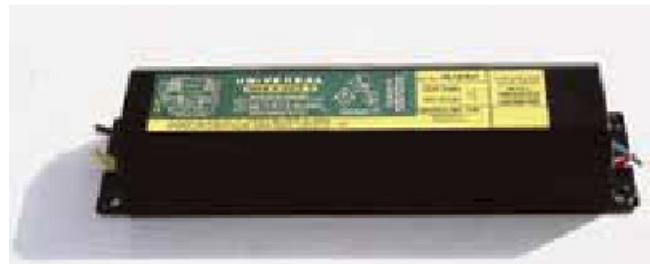
If a ballast contains PCBs, the PCBs are located inside the small capacitor or in

the surrounding potting material. There will be approximately 1 to 1½ ounces of PCBs in the capacitor itself and smaller amounts in the potting compound, a black, tar-like substance on the internal electrical components.

PCB leaks from ballasts typically take 2 forms: a clear to yellow, oily liquid, the PCB oil itself, or the liquefied black potting material. If the ballast fails or overheats, the capacitor may break open and both the oil and the potting material may be released. The capacitor does not always leak when the ballast fails, but measures should be taken to limit or avoid personal exposure in all cases.
